Manhole Inspection Summary

Manhole # S01CC2023MH

Insp Date: **9/27/06 1:02 PM**

Location Address: **3215 Bancroft Rd** Cross Street: **Cross Country Blvd**

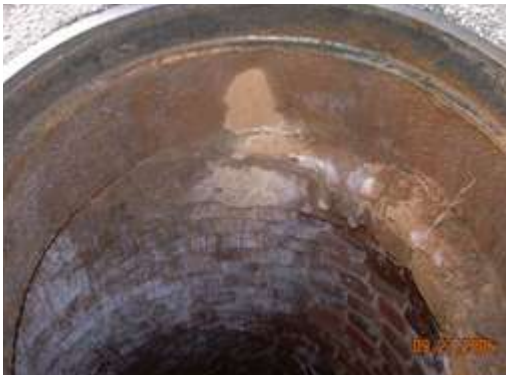
Defect

Chimney / Frame Adjustment ☒ Exists Material: **Brick** ☐ Parged Height: **3** (in.)
Condition: ☐ Sound ☐ Cracked ☐ Root Intrusion ☒ **Loose Brick** ☐ Deteriorated
Infiltration: ☐ None ☒ **Joint** ☐ Cracks ☒ **Mortar** ☐ Roots ☐ Wall

Offset and Joint leak @ rim

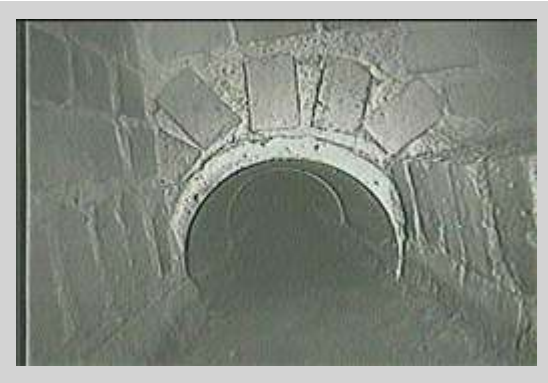
10 in. Circular Gravity Sewer Pipe Out @ 12 O'Clock

Invert Depth: **10.05** (ft.) Flow Characteristics: **Fast**

Infiltration: **None** Pipe Seal Cond: **Sound**

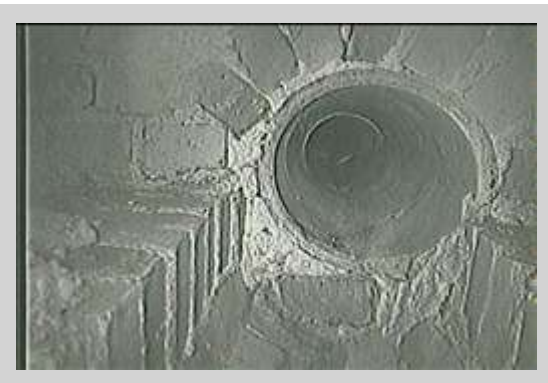
8 in. Circular Gravity Sewer Pipe In @ 5 O'Clock

Invert Depth: **9.25** (ft.) Flow Characteristics: **None**

Infiltration: **None** Pipe Seal Cond: **Sound**

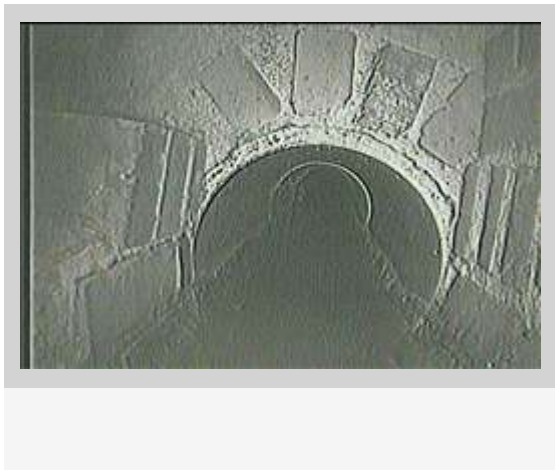
10 in. Circular Gravity Sewer
Pipe In @ 6 O'Clock

Invert Depth: **9.94** (ft.) Flow Characteristics: **Fast**

Infiltration: **None** Pipe Seal Cond: **Sound**
